ANNUAL REPORT FOR 2008

R-2206B Mitigation Site
Lincoln County
TIP No. R-2206B

Prepared By:
Natural Environment Unit & Roadside Environmental Unit
North Carolina Department of Transportation
December 2008

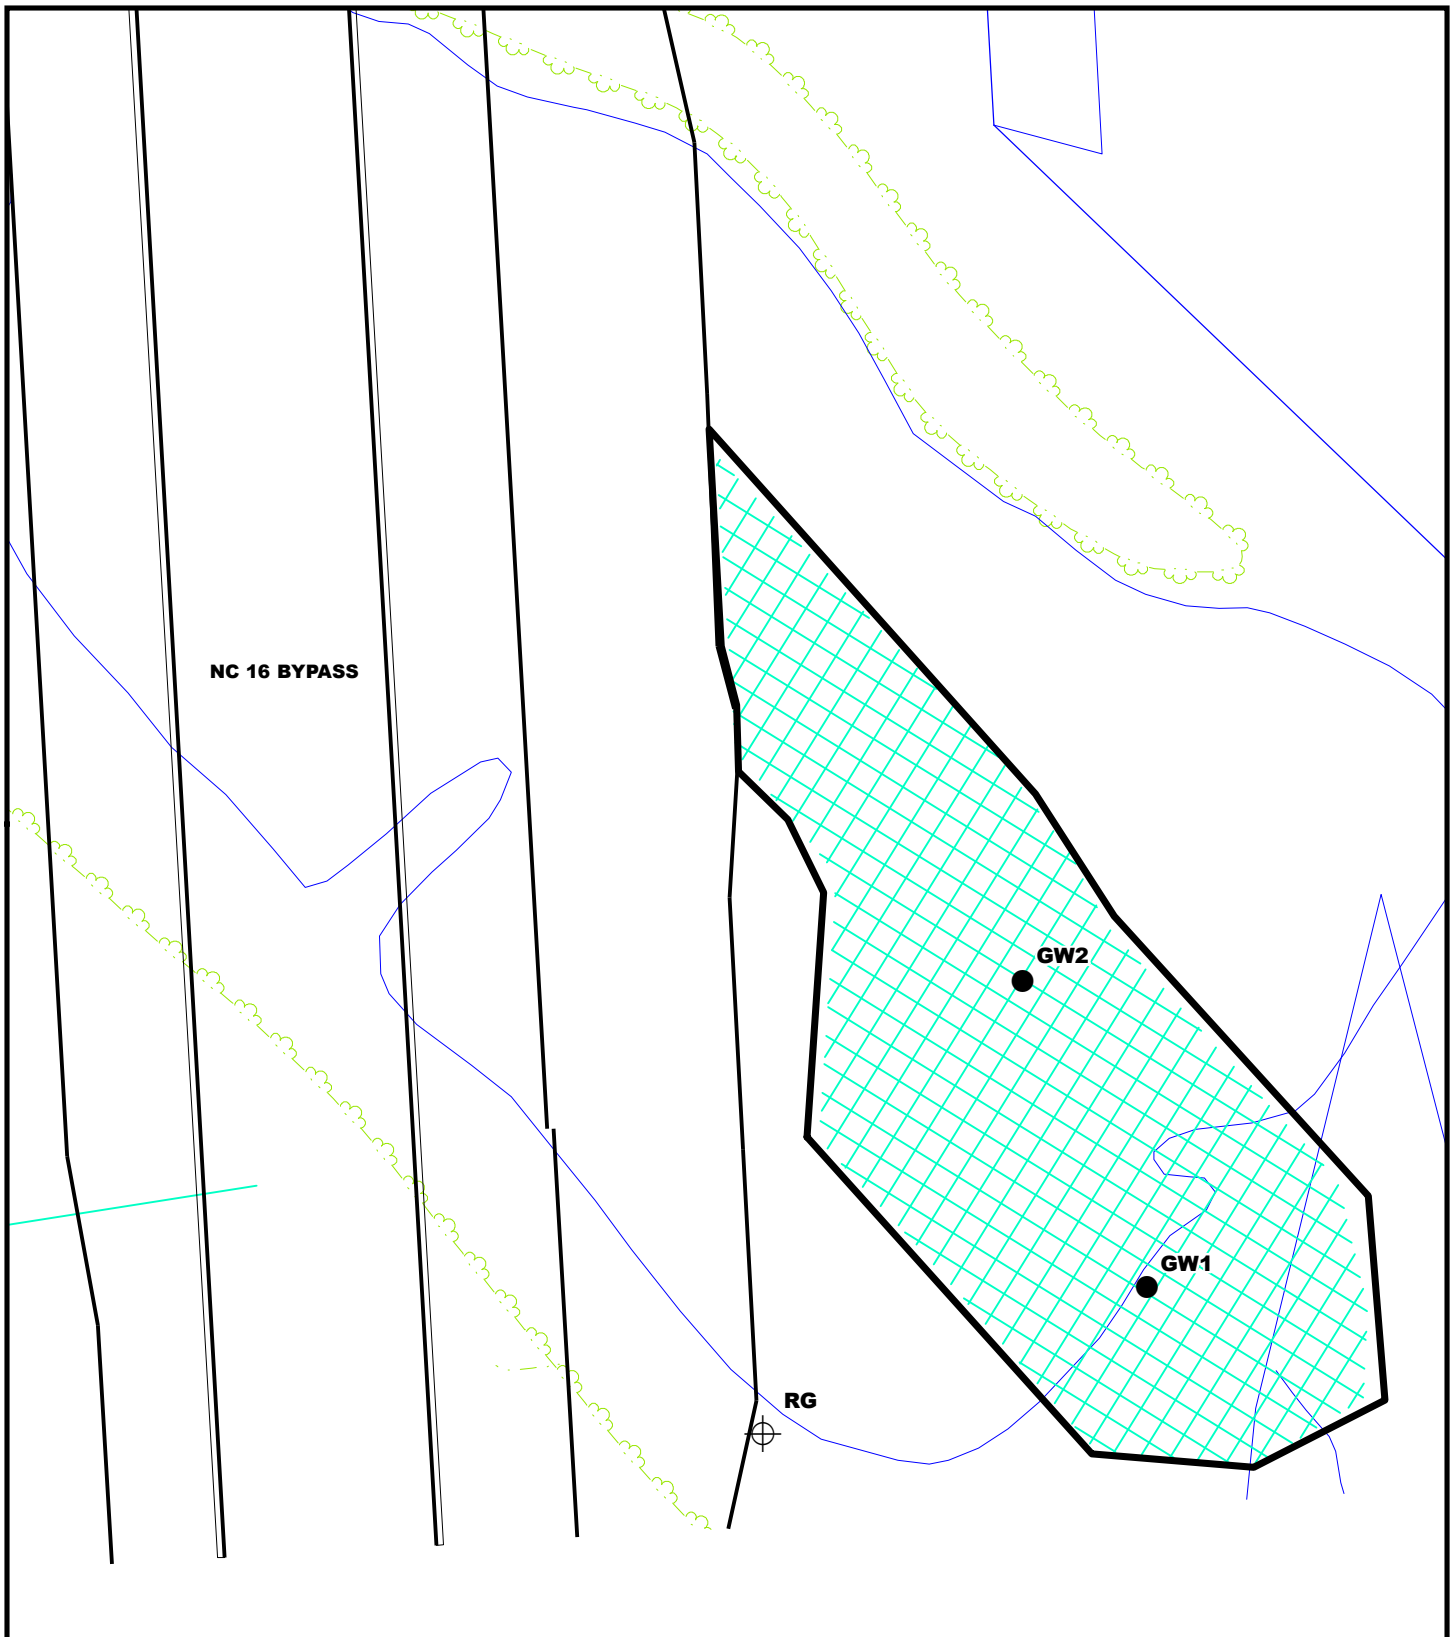
Figure 2. Gauge Location Map

Two groundwater monitoring gauges were installed on the site (Figure 2) in February 2008 in the wetland restoration area. The groundwater gauges record water levels on a daily basis. A rain gauge is also located on the site to assist in comparison of the rainfall data from an official weather station in Lincolnton (supplied by the NC State Climate Office). Monitoring data for 2008 represents the first year of hydrologic monitoring for the site.

- Groundwater Gauge
- ⊕ Rain Gauge

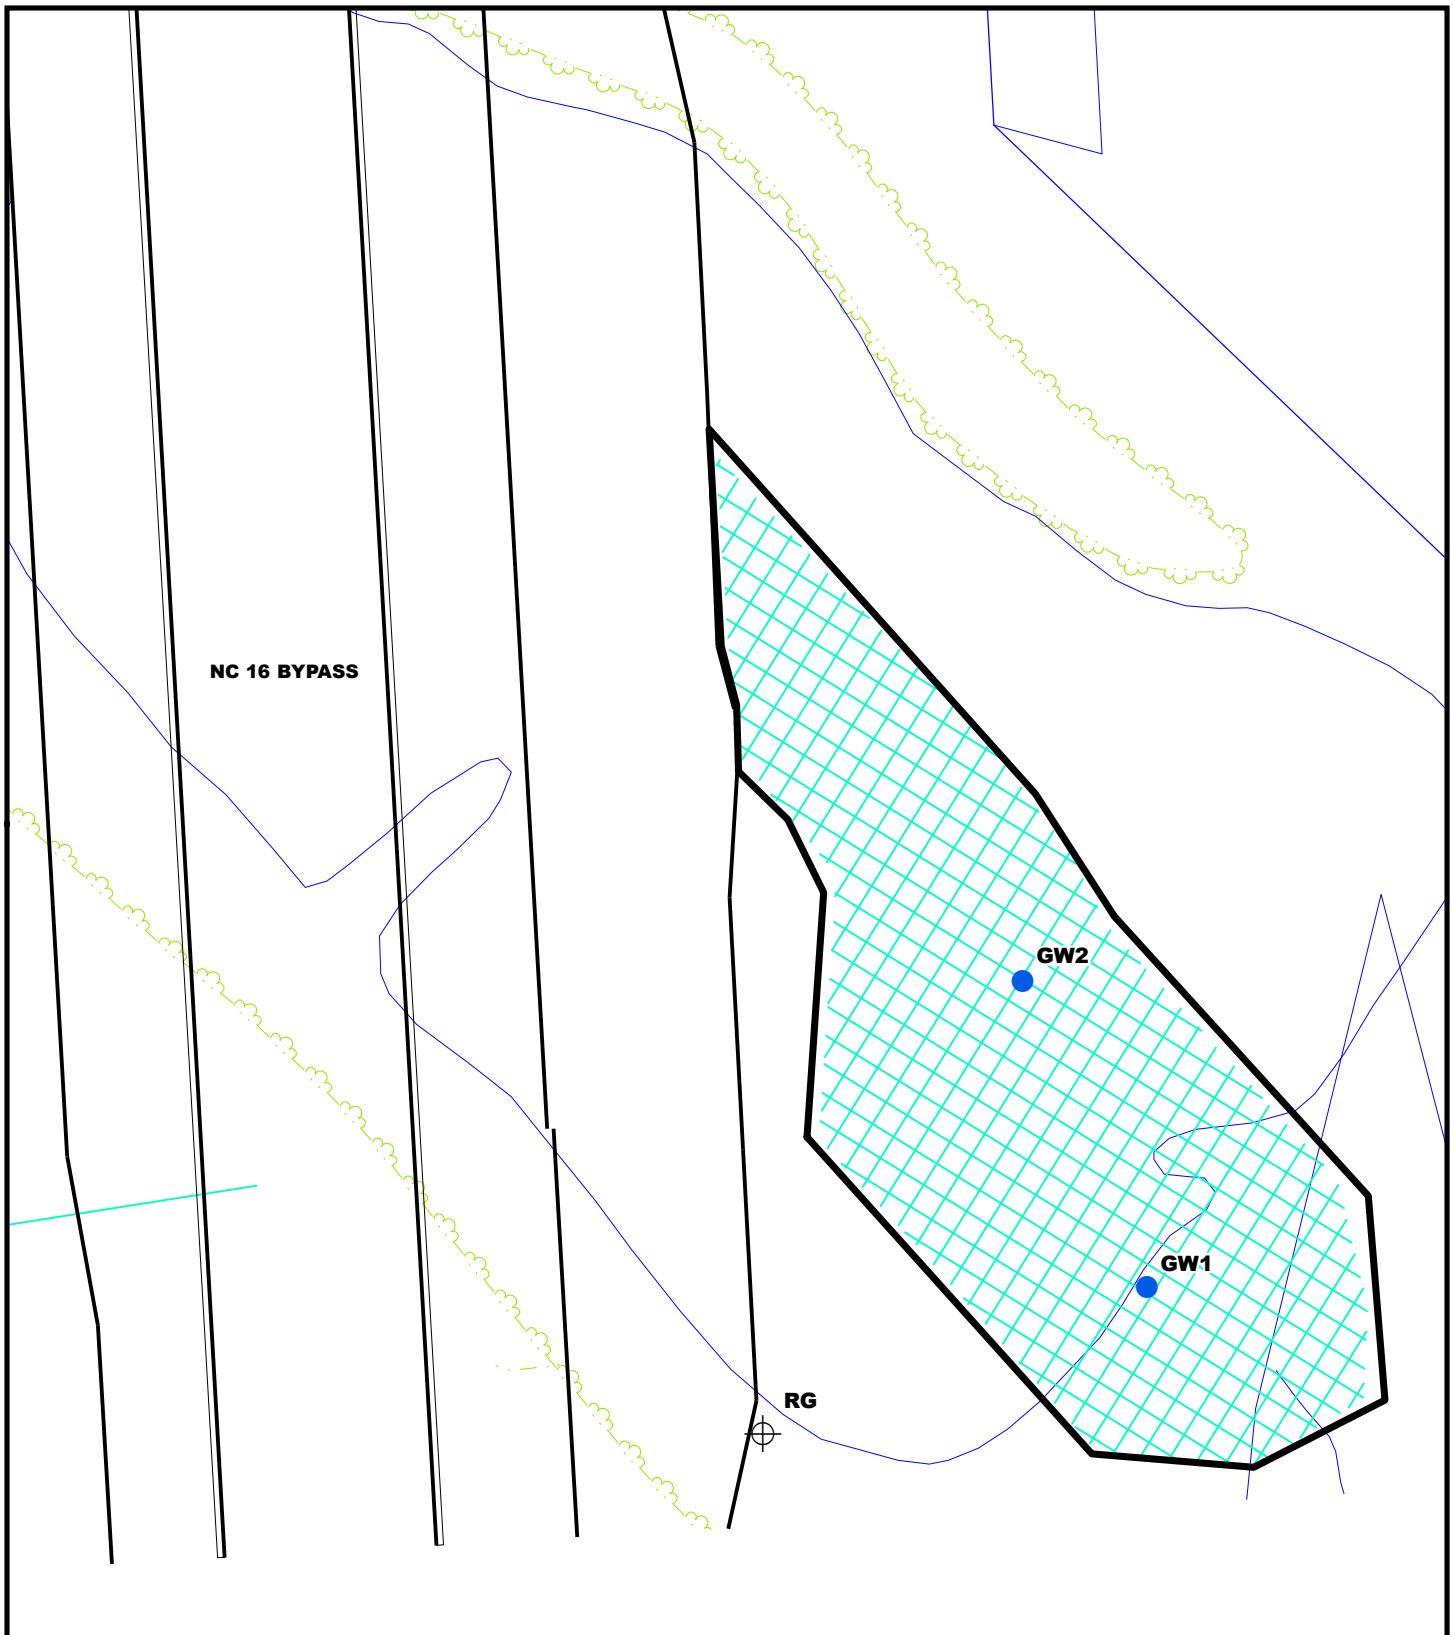
Figure 3. Hydrologic Monitoring Gauge Results

The maximum number of consecutive days that the groundwater was within twelve inches of the surface was determined for each gauge. This number was converted into a percentage of the 222-day growing season. The results are presented in Table 1. Figure 3 also provides a graphical representation of the hydrologic results. Gauges highlighted in blue indicate wetland hydrology for more than 12.5% of the growing season. Those gauges highlighted in black indicate no wetland hydrology (< 5% of the growing season).

- 0 - < 5%
- 5 - 8%
- 8 - 12.5%
- > 12.5%

Monitoring Gauge	< 5%	5-8%	8-12%	> 12.5%	Actual %	Success Dates
GW-1+				X	100	March 23 - Nov 4
GW-2+				X	100	March 23 - Nov 4

The 2008 monitoring year represents the first year of hydrologic monitoring for the R-2206B Mitigation Site. Both groundwater monitoring gauges recorded jurisdictional hydrology above the required 12.5% of the growing season.

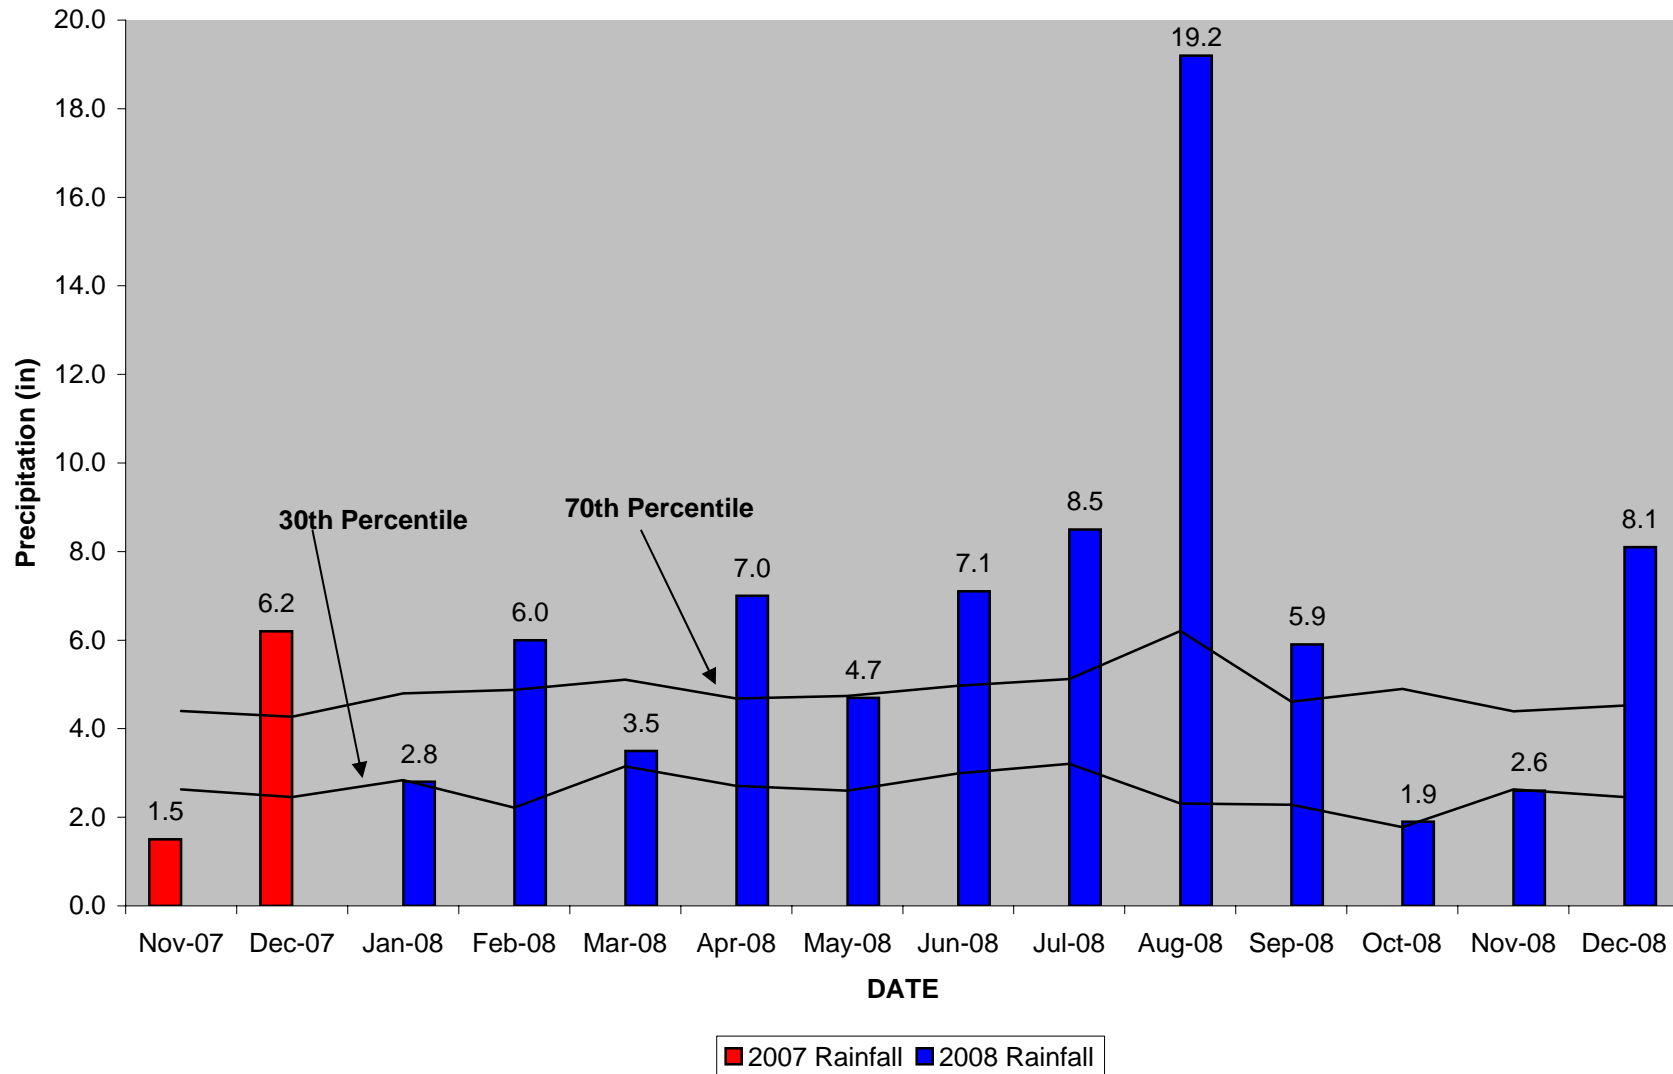
**R-2206B Mitigation Site
Figure 4 (30-70 Percentile Graph)
Lincolnton, NC**

Figure 4 is a comparison of the 2008 monthly rainfall to the historical precipitation (collected between 1977 and 2008) for Lincolnton, North Carolina. This comparison gives an indication of how 2008 relates to historical data in terms of climate conditions. The NC State Climate Office provided all of the historical rainfall information.

Based on the historical data, January, March, May, October, and November recorded average rainfall for the site in 2008. The months of February, April, June, July, August, September, and December recorded above average rainfall. Overall, the 2008 monitoring year was an average to above average rainfall year.
